# King Street, Quaker Lane and Braddock Road Traffic Study

Transportation and Environmental Services Department

August 17, 2011  
Revised October 27, 2011

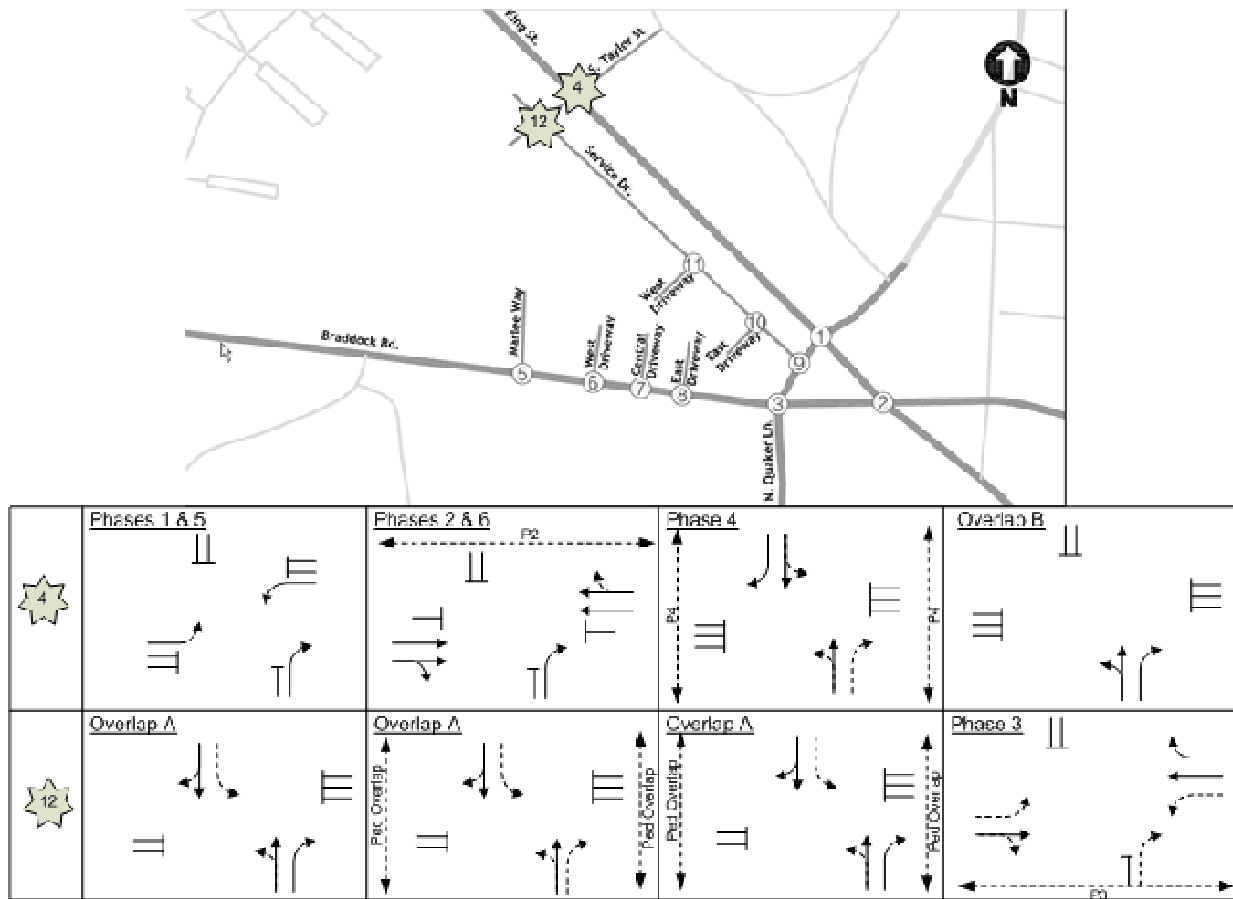
Figure 5

Under the proposed operation the eastbound King Street right turn into the shopping center would only be prohibited when the light is red. Rather than have concurrent green indications for the service road and King Street, the proposed signal operation separates these two movements, thus, not requiring an outright prohibition on right turns. The proposed operation is depicted in Figure 5.

Phasing Diagram for the proposed signal at Taylor and King Street Service Road

The service road intersection with the shopping center parking lot was evaluated for possible signalization. The VHB report recommended closing off the service road at this point to improve pedestrian access and to eliminate cut through traffic on the service road. A traffic signal can accomplish the goals of the proposed closure while allowing access to remain.

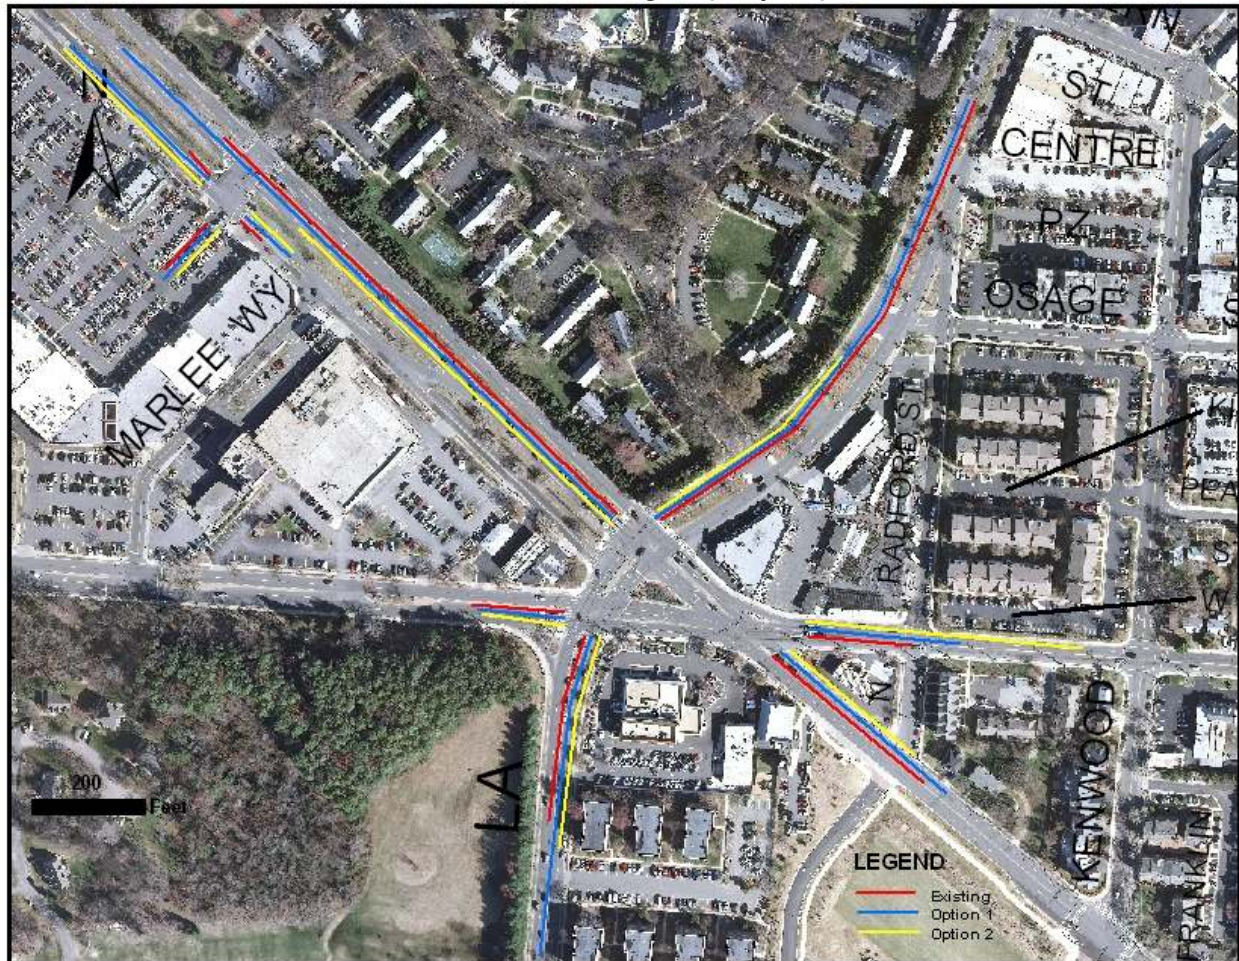
**Figure 6**  
VISSIM Queue Lengths (PM peak)

A VISSIM analysis of the above scenarios was performed for the PM peak hour to evaluate any potential impacts these proposals would have. The AM peak hour conditions were analyzed because the PM peak hour volumes are significantly higher due to the presence of a large retail development within the study area. VISSIM was chosen as the analysis tool rather than SYNCHRO or HCM because VISSIM accounts for the interaction between all of the intersections in a network. SYNCHRO and HCM do not account for traffic queue spillover. The results of the VISSIM analysis are shown in Table 2 and Figure 6:
